# Manhole Inspection Summary

Manhole # S29M\_\_040MH

Insp Date: **12/4/08 8:44 AM**

**Location** Address: **753 W.Hamburg St.**

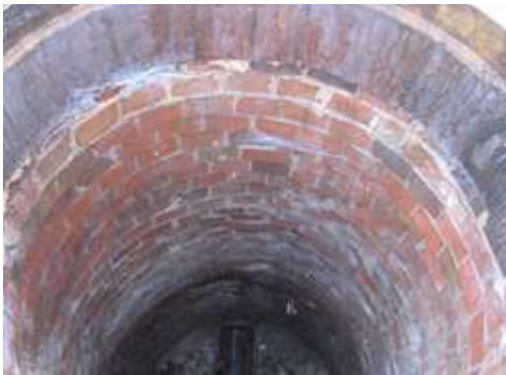
Miscellaneous

view of manhole

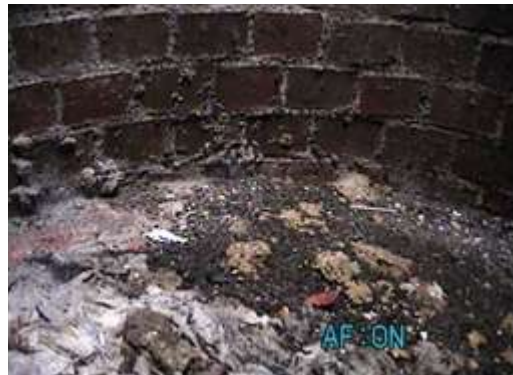
Defect 2

Condition: ☐ Sound ☐ Cracked ☐ Root Intrusion ☐ Deteriorated ☐ Leaks ☒ **Debris**

debris on the bench

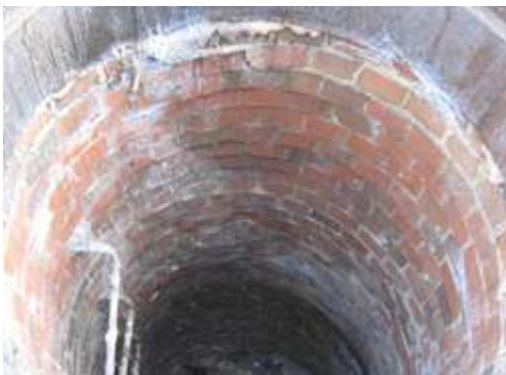
Defect 1

Infiltration: ☐ None ☐ Joint ☐ Cracks ☐ Mortar ☐ Roots ☒ **Wall**

corbel wall infiltration, corroded steps

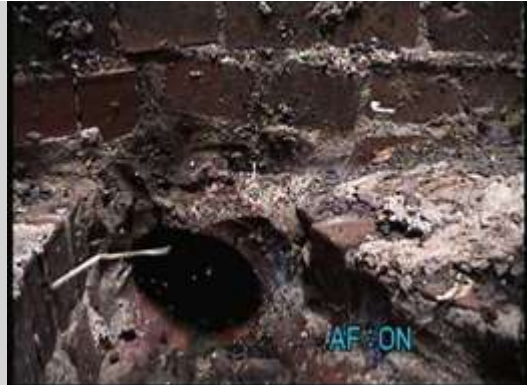
12 O'Clock Outflow

6 in. Circular Gravity Sewer  
Pipe Out @ 12 O'Clock

Pipe Height: **6** (in.) Rod and Bar (Angled)  
Pipe Material: **Clay** ☐ Pipe Lined  
Invert Depth: **10.45** (ft.) Flow Characteristics: **None**  
Deposits: ☒ None ☐ Mud ☐ Sludge ☐ Debris ☐ Grease  
Silt Depth: **0** (in.) Deposits Extent:  
Infiltration: **None** Pipe Seal Cond: **Sound**

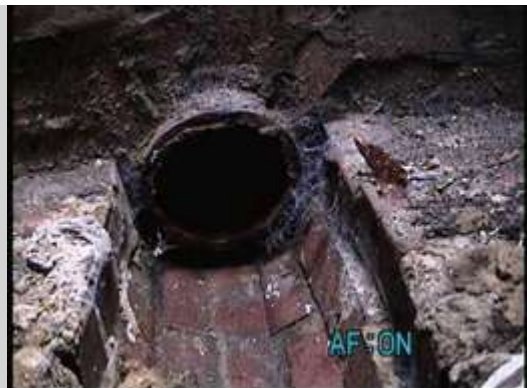
3 O'Clock Inflow

6 in. Circular Gravity Sewer  
Pipe In @ 3 O'Clock

Pipe Height: **6** (in.) Rod and Bar (Angled)  
Pipe Material: **Clay** ☐ Pipe Lined  
Invert Depth: **9.60** (ft.) Flow Characteristics: **None**  
Deposits: ☒ None ☐ Mud ☐ Sludge ☐ Debris ☐ Grease  
Silt Depth: **0** (in.) Deposits Extent:  
Infiltration: **None** Pipe Seal Cond: **Sound**
